IPC2010-11888

## EVOLUTION OF TRIAX MAGNETIC FLUX LEAKAGE INSPECTION FOR MITIGATION OF SPIRAL WELD ANOMALIES

### ABSTRACT

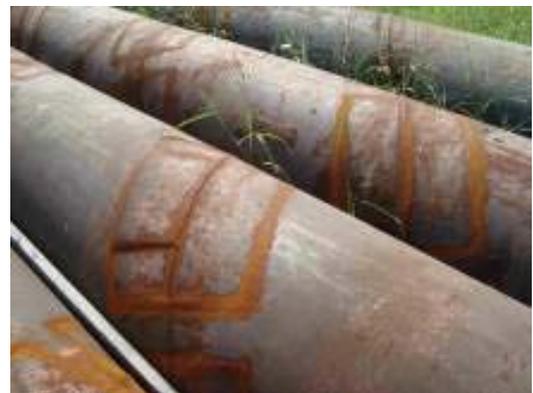
Figure 7. Test Spools containing manufactured spiral weld defects.

An initial manufactured defect set was determined via a GE 6-Sigma technique known as a "Design of Experiments" or "DoE". [9] The defects varied in length, width opening, depth, position in weld and internal/external surface location as shown in Figure 6. PetroChina accepted the challenge to manufacture the defects with a photograph illustrating such examples as shown in Figure 7.
